# WASH EMERGENCY RESPONSE MISSION REPORT APRIL TO JUNE, 2019

TONGOGARA REFUGEE CAMP

## GENERAL FINDINGS AND OBSERVATIONS

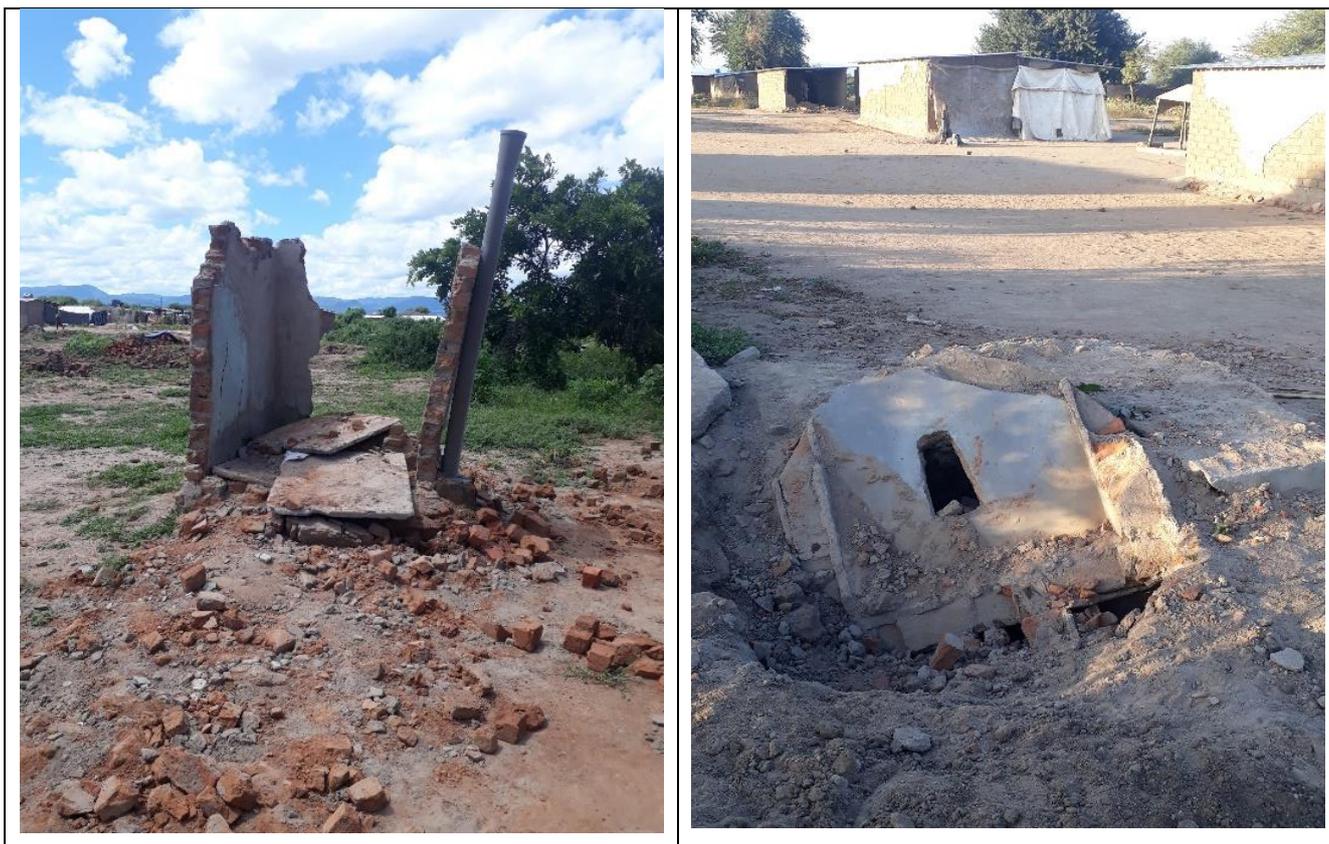
- **Latrine Constructions:** Cyclone Idai hit Zimbabwe in March, 2019 resulting in the collapse of 618 latrines in Tongogara Refugee Camp according to the Inter-agency Rapid Assessment that was conducted after the Cyclone. UNHCR and GOAL Zimbabwe immediately responded by replacing 206 totally damaged latrines with semi-permanent latrines as an interim solution and later on replaced with Blair VIP latrines while the remaining 412 will be rehabilitated with material support to the affected refugees and asylum seekers. Assessment and verification of

**Impacts of Cyclone Idai in Section 7 at Tongogara Refugee Camp**

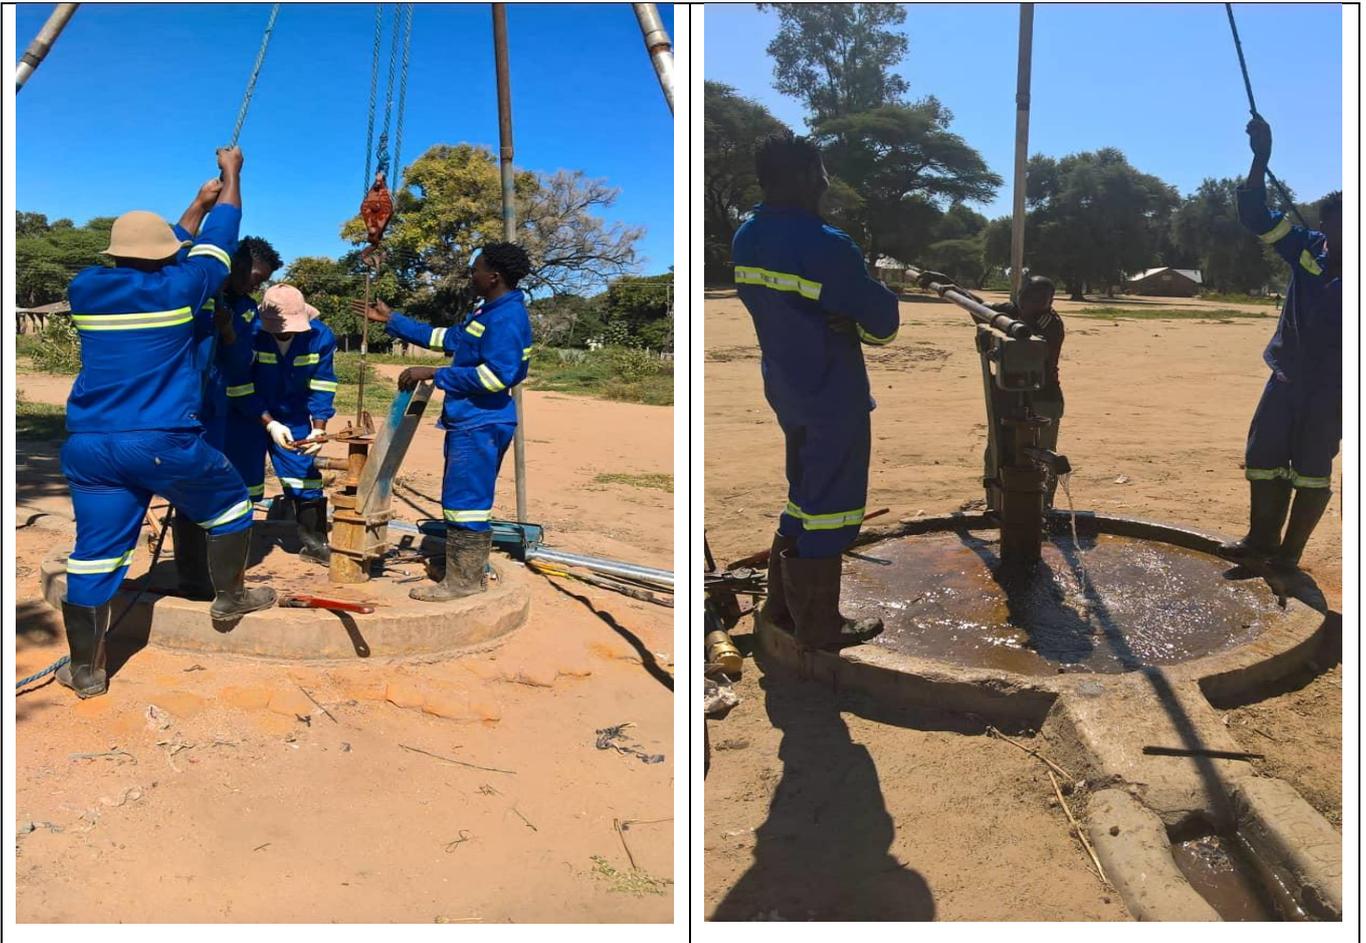
- **Rehabilitation of the 4 Hand Pumps:** Assessment of the water sources to establish functional sources was conducted. According to the assessment, out of 11 hand pumps throughout the camp, only 7 hand pumps were functional and 4 non-functional. Rehabilitation of non-functional hand pumps to increase the access of water to refugees was done. Rehabilitation was conducted for 2 hand pumps in Section 1, 1 hand pump in Section 6 while 1 hand pump in Section 6 remained beyond repair thus 10 hand pumps are currently functional in the entire camp.

**Rehabilitation of the non-functional Boreholes in Section 1, 4 and 6 in Tongogara Refugee Camp**

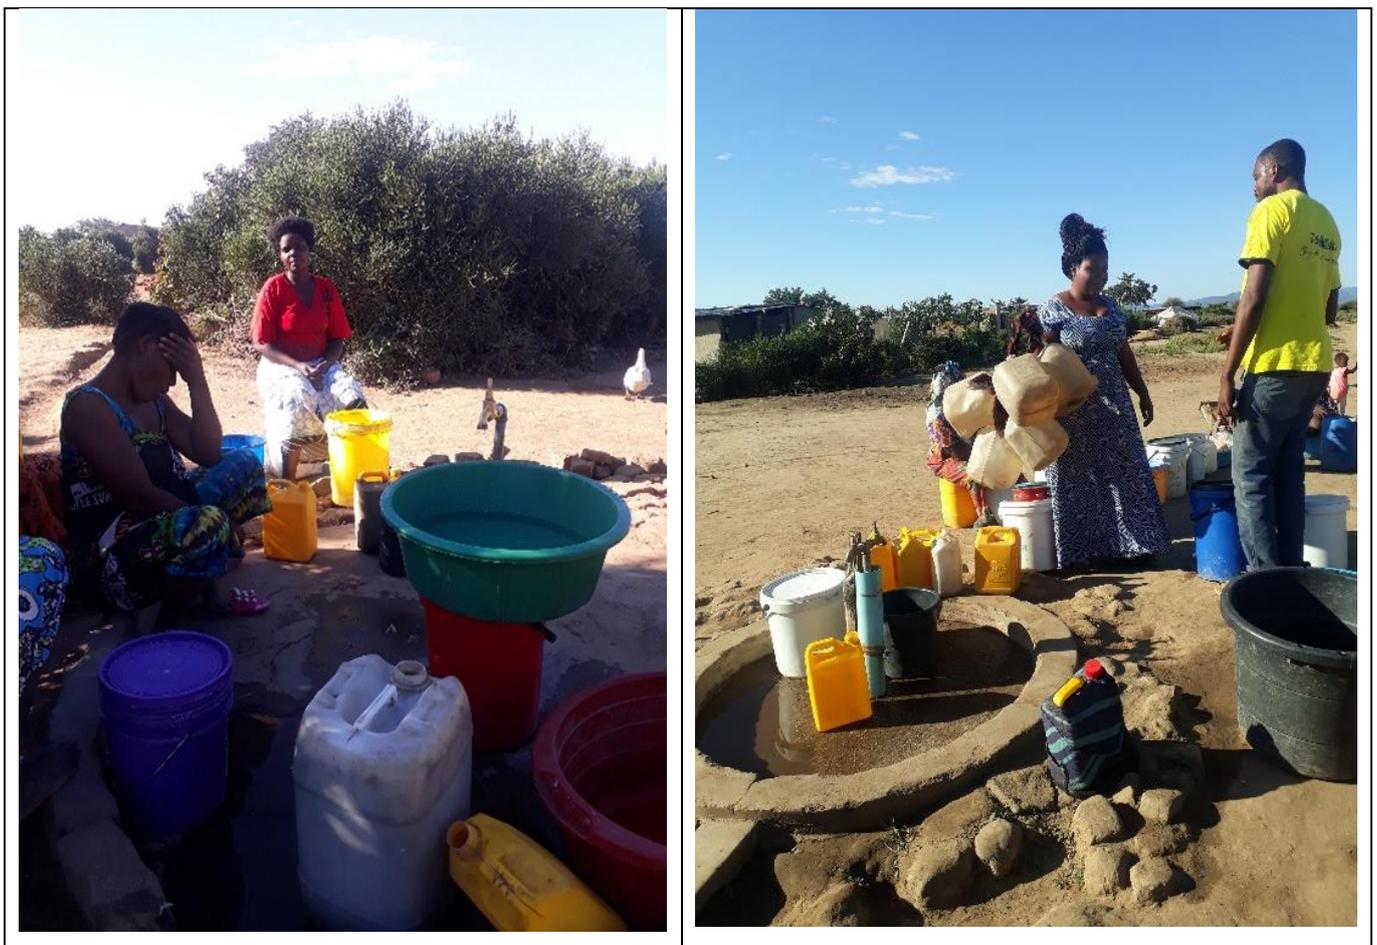
- The camp has 5 deep well boreholes which pump water to 11 tank stations in each Section (1-9) including Police Station and Child Friendly Spaces. Water from the centralized system is working only for 2 to 3 hours a day and water is pumped from 4 BHs while 1 BH is currently non-functional due to wild animals interference.
- 12 hand pumps (bush type) as additional water sources for Section 1 to 9. Currently 10 hand pumps are functional except 1 hand pump which is beyond repair and abandoned in Section 6. 1 new drilled hand pump which is expected to serve families in the extension Section 9.

Refugees and Asylum Seekers queuing for water at the tap stand in Section 6

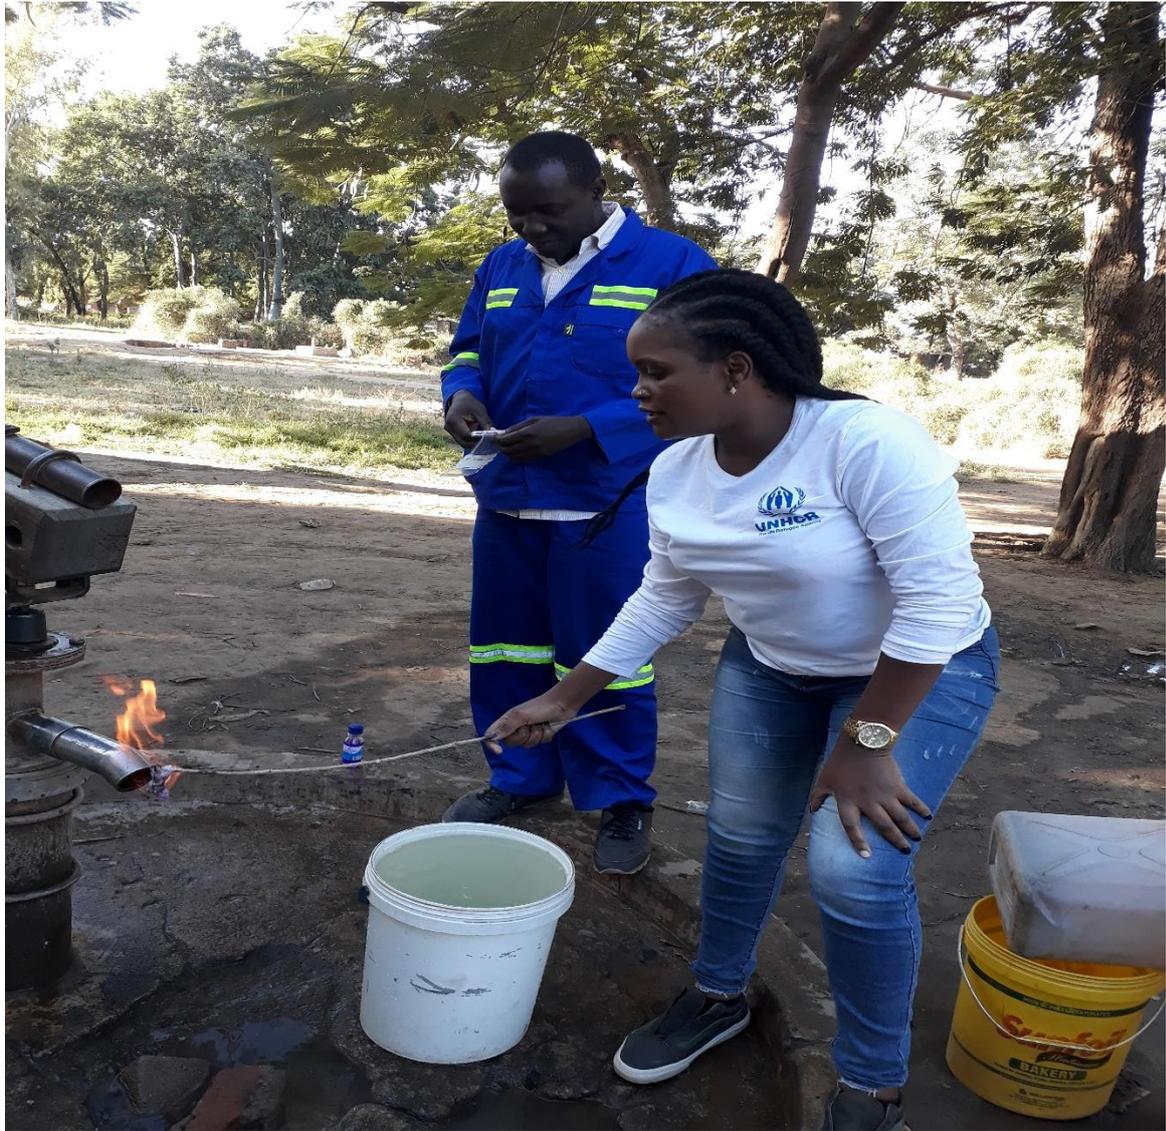
- Water quality monitoring is conducted once a month at the Environmental Health Department in Chipinge District. Samples are collected from both tap stands (centralized system) and hand pumps from different locations. Additionally, Environmental Health Technician from Terre des Hommes (TDH) has been trained to conduct bacteriological water analysis. Microbiological water analysis is currently conducted on site and samples are collected from tap stands, hand pumps and at the household level on a weekly basis by Terre des Hommes (TDH) using a Compartment Bag Test Kit.

**Water Quality Samples Collection at the Borehole in Section 1**

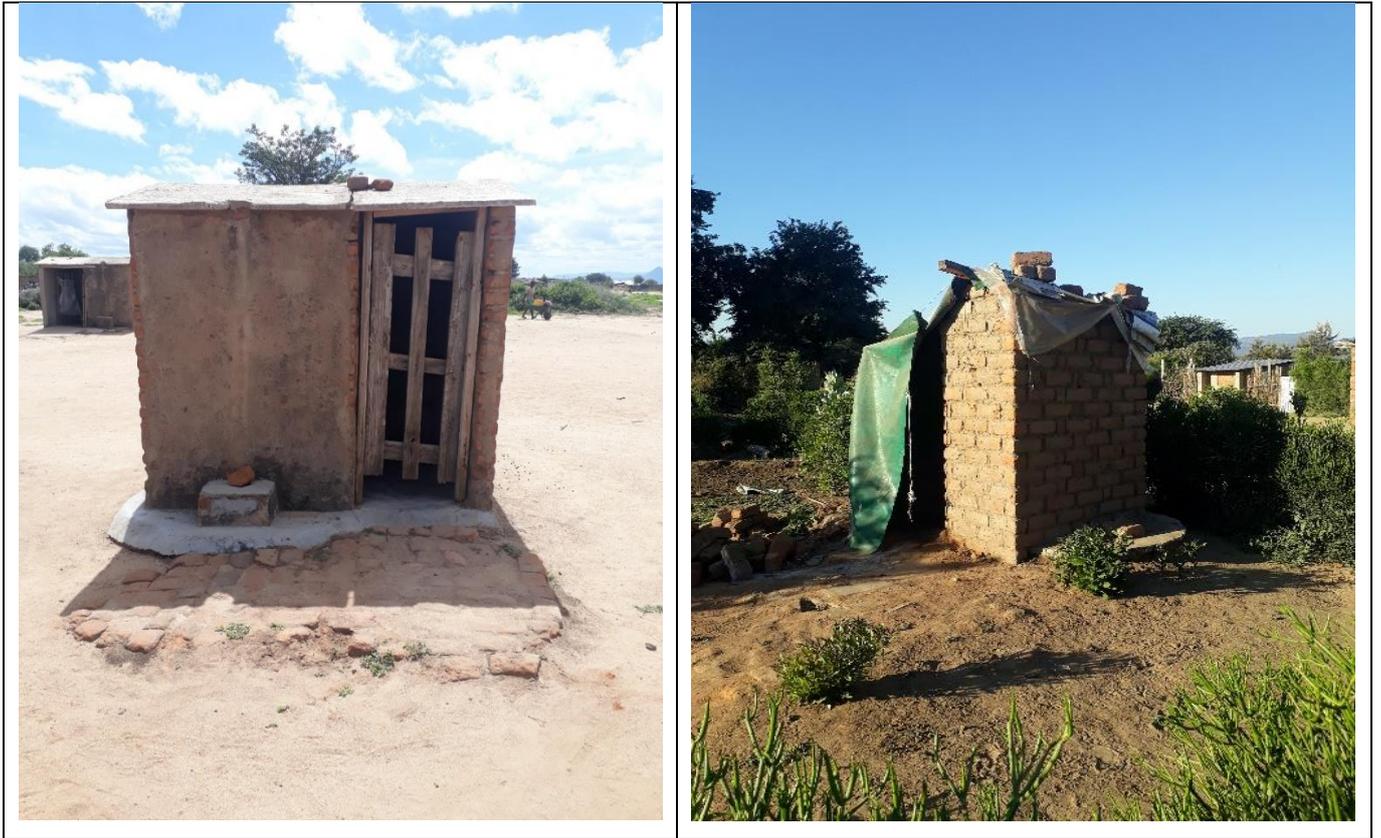
- There are three types of latrines constructed at Tongogara camp which includes Blair VIP latrines, Upgradable Blair VIP latrine (uBVIP) and Emergency/Shared latrines. Many refugees share or construct their own latrines using different locally available materials due to funding limitations. Moreover, there are bathing shelters in the entire camp and refugees improvise their own type of these shelters using locally available materials.

**Types of latrines in Tongogara Refugee Camp**

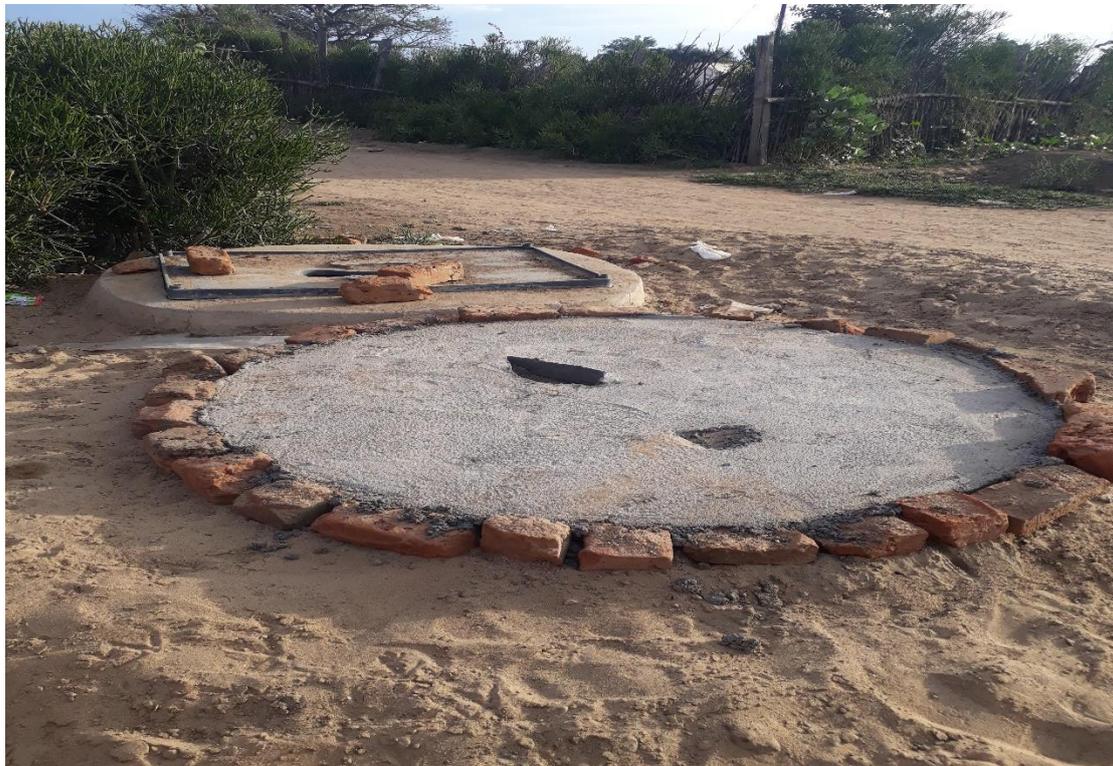
**Fabrication of slabs to replace the semi-permanent plastic slabs is Section 6**

- **Construction of Latrines:** Verification of the 206 latrines that were totally damaged by Tropical Cyclone Idai was conducted in Section 6 and 7 including the Transfer Centre. Immediately after Cyclone Idai, 206 latrines were replaced with semi-permanent structures but later on upgraded to BVIP permanent structures. Construction of the permanent latrines is ongoing and additional 710 BVIP latrines are expected to be constructed by December, 2019.

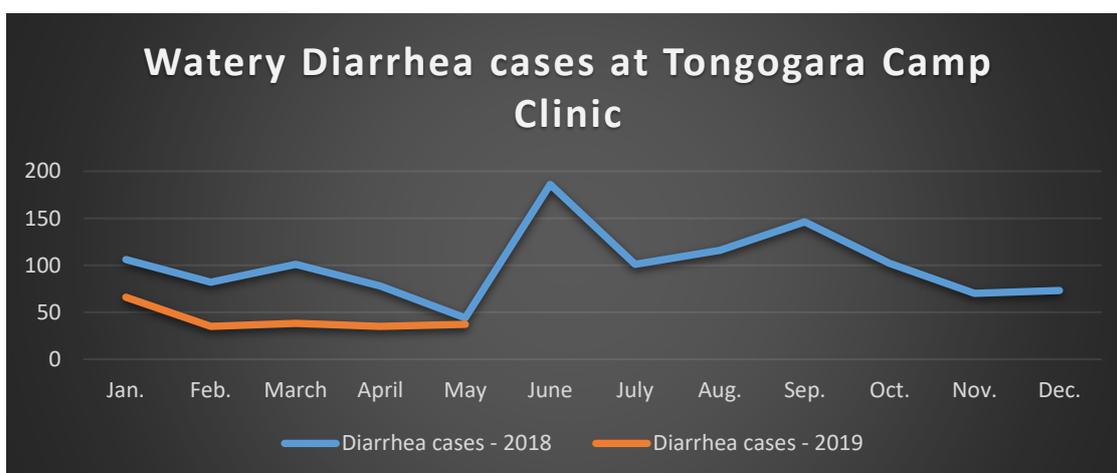
**Trends of Water Diarrhoeal Cases in Tongogara Refugee Camp for 2018 and 2019<sup>4</sup>**

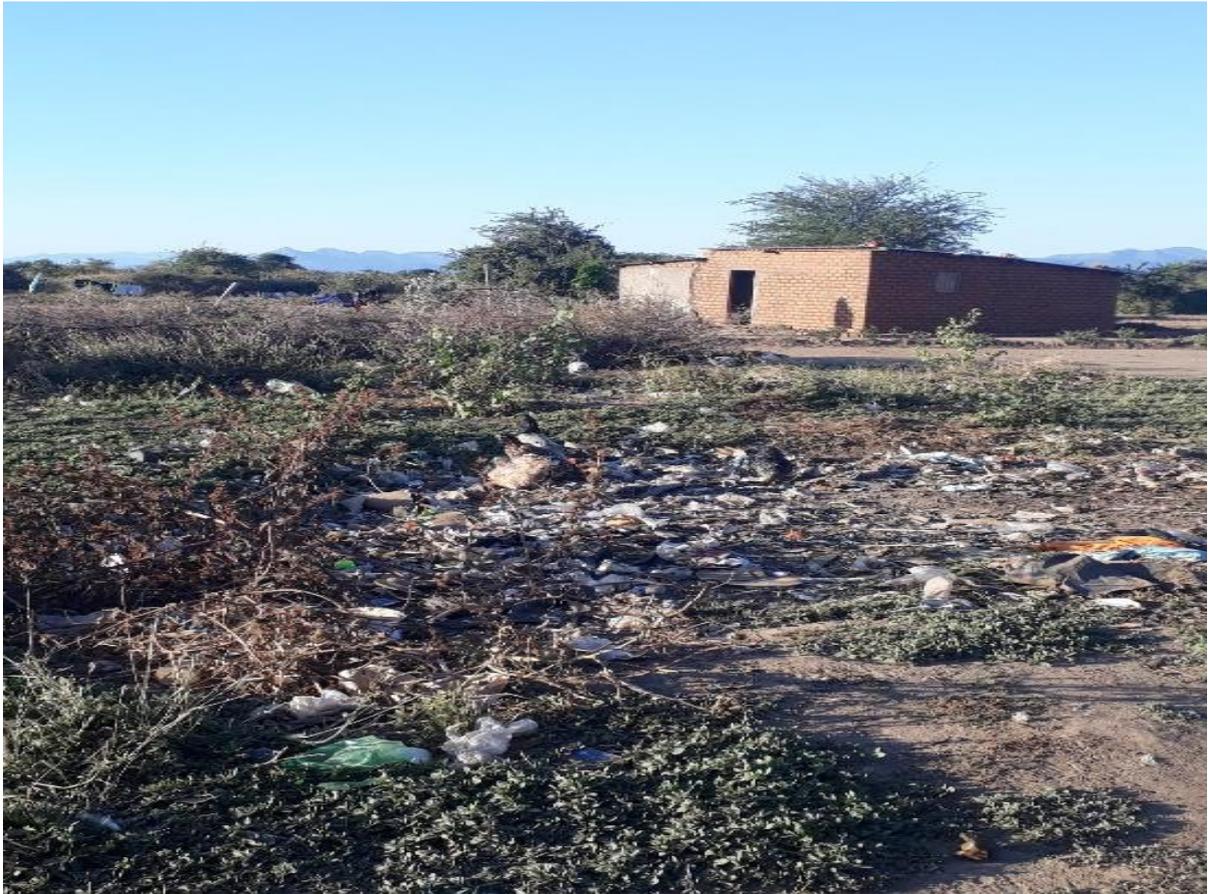
**Dispersed garbage in Section 7**

Solid waste management is very poor in Tongogara Refugee Camp despite the efforts from GOAL Zimbabwe and all the partners to ensure monthly clean up campaigns, dust bins and refuse pits provision to the refugees. Improper dumping sites in the entire camp is evident especially in markets, refugees dump waste anywhere in the camp including loitering of livestock who largely contribute to dispersing waste from dump sites.

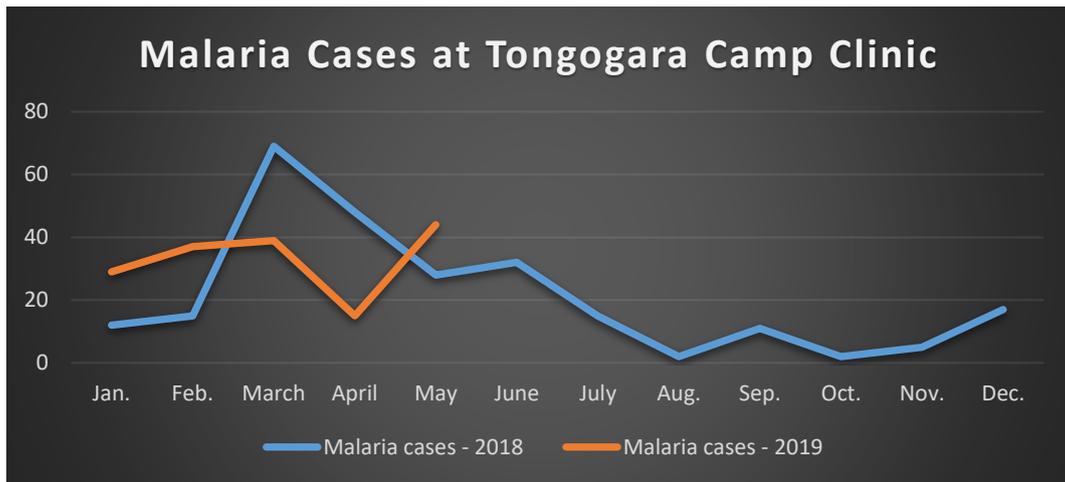
The camp lies on a flat area which is flood prone with less than 1% slope therefore during flash floods or rainy season there is stagnant water throughout the camp especially near the market area, this was evident after Cyclone idai. Additionally, at the water points grey water is inevitable due to daily activities such as washing clothes and water collection thus water exceeds the soakaway pit flowing to different directions due to the nature of drainage system. Standing water contributes largely in breeding of malaria parasites among other vectors. The rise of Malaria was evident after the Cyclone Idai but the total number of cases was relatively low compared to the same period in 2018 as shown below;

Trends of Malaria Cases in Tongogara Refugee Camp for 2018 and 2019<sup>5</sup>

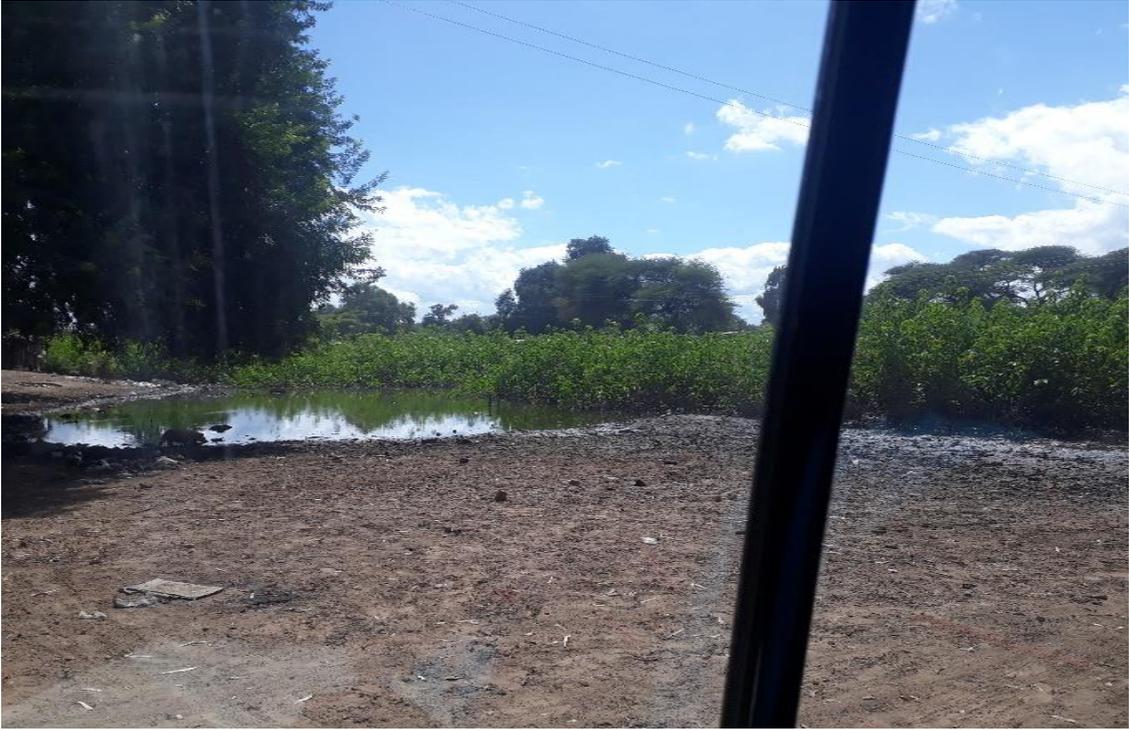
**Stagnant Water near the market after Tropical Cyclone Idai**

- **Clean Up Campaigns:** The weekly routine clean up campaigns are ongoing in various Sections in the camp after Cyclone Idai. Refugees are mobilized by the Community Health Promoters to clean their surroundings in order to decrease the likelihood of diseases outbreak and mosquito breeding areas.
- Indoor Residual Spray and distribution of nets to refugees to control vectors is conducted by Terre des Hommes (TDH).

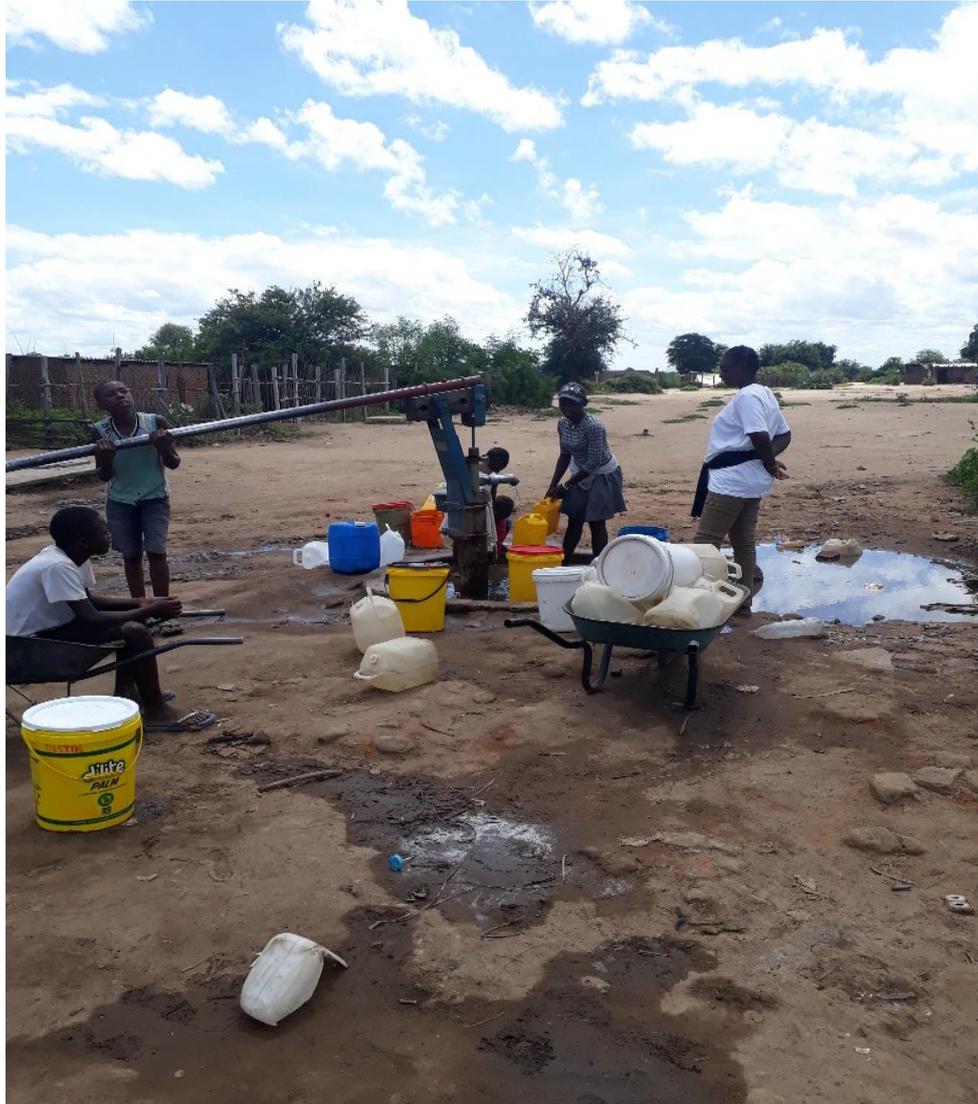
**Standing water at the Borehole in Section 6**

Grey water originating from tap stand and hand pump spillage while refugees collect water and standing water from flash floods during rainy season is a major concern since it impacts the quality of environmental hygiene and can possibly generate breeding sites for vectors where water pools on the surface and is unable to rapidly saturate into the soil. Although most tap stands have soakaway pits installed the volume of greywater generated often exceeds the infiltration capacity of the typical soakaway pit and spills to the nearby households.

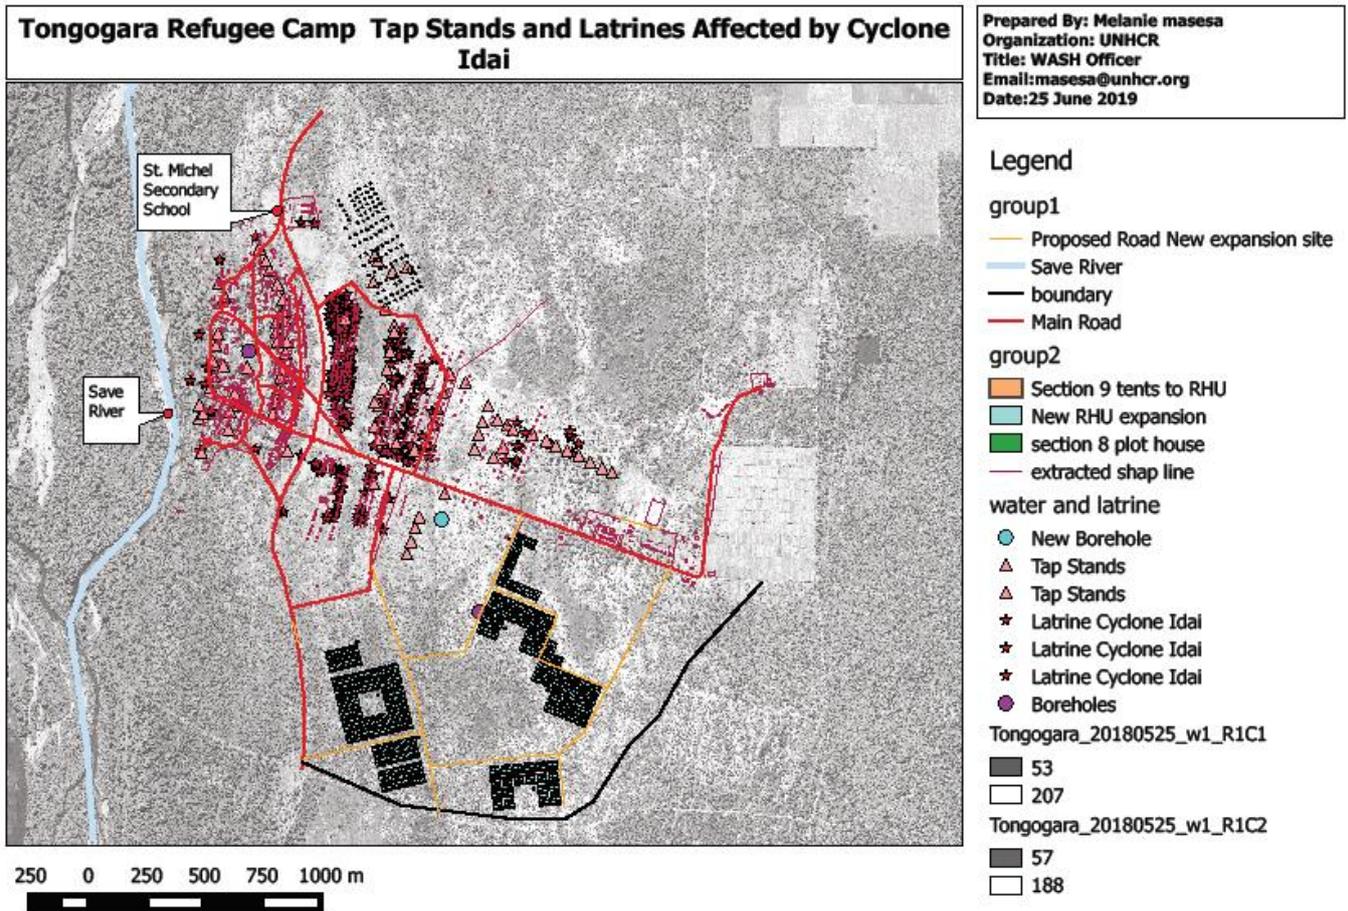
Annex 1: Map of Tongogara Camp WASH Facilities

**Annex 1:** Map of Tongogara Camp WASH Facilities (Tapstands and Cyclone Idai Affected Latrines)
